Manhole Inspection Summary

Manhole # S43C2_017MH

Location Address: **3751 Saint Margaret St** Cross Street: **Washburn Ave.**

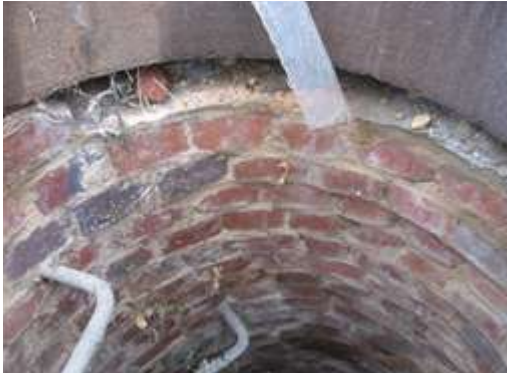
Defect 1

Chimney / Frame Adjustment ☒ Exists Material: **Brick** ☐ Parged Height: **0** (in.)
Condition: ☐ Sound ☐ Cracked ☐ Root Intrusion ☒ **Loose Brick** ☐ Deteriorated
Infiltration: ☐ None ☐ Joint ☐ Cracks ☒ **Mortar** ☐ Roots ☒ **Wall**

Corbel Material: **Brick** ☐ Parged Type: **Concentric/Eccentric**
Condition: ☐ Sound ☐ Cracked ☐ Root Intrusion ☒ **Loose Brick** ☐ Deteriorated
Infiltration: ☒ None ☐ Joint ☐ Cracks ☐ Mortar ☐ Roots ☐ Wall

Loose bricks

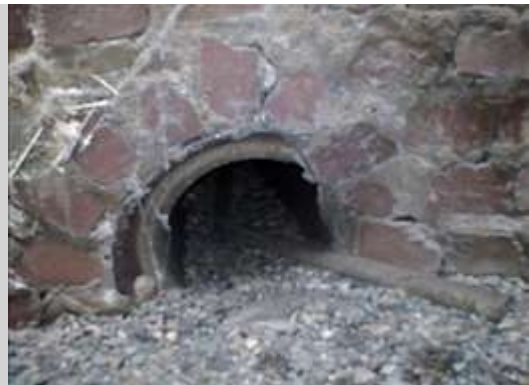
12 O'Clock Outflow

8 in. Circular Gravity Sewer
Pipe Out @ 12 O'Clock

Infiltration: **None** Pipe Seal Cond: **Sound**
